45 HOLLOWAY ROAD

23/4/2017

Discussion paper: The problems associated with the entrance plinth and adjacent area

This review of the condition of entrance plinth and adjacent hard landscaping aims to define the problems and begin to explore options for a solution

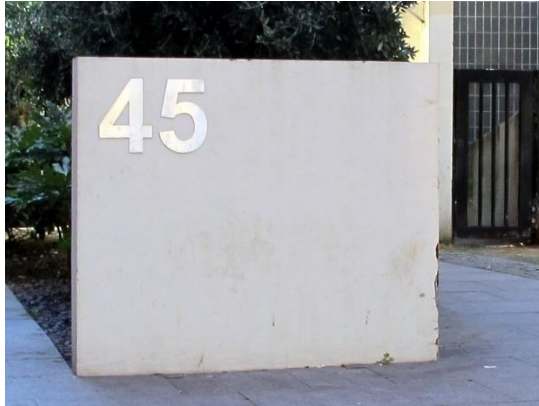
The plinth has suffered damage over the years. It is chipped on the corners facing the motorbike parking, perhaps from collisions with motorbikes (which park next to it on the magistrates' side.)

- The flat top of the plinth creates a tendency for it to be used as a shelf for litter.
- The height of the plinth lends it to being used as a screening device and encourages its use as a lavatory.
- The garden area immediately behind the plinth is now denuded of plants, has lost most of its slate chippings and attracts rubbish.
- As well as the unsavoury nature of what happens behind the plinth, the area has become potentially dangerous. Residents and others have been confronted by people concealed by the plinth, and syringes have been found among the debris.
- The plants directly behind the plinth have died. Previous attempts to plant low shrubs against the plinth to deter people urinating weren't successful.
- The area is smelly and possibly a health hazard – especially to children.

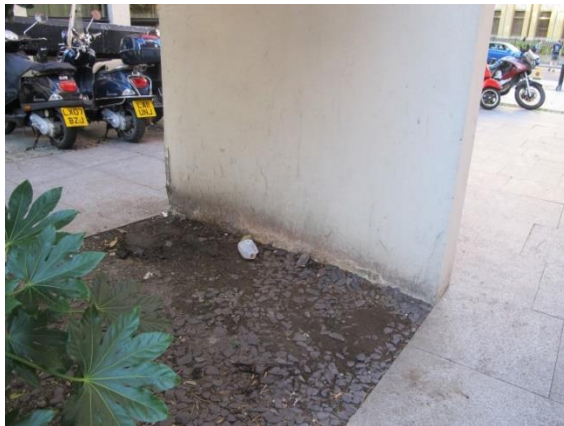
Rubbish is regularly found behind the plinth

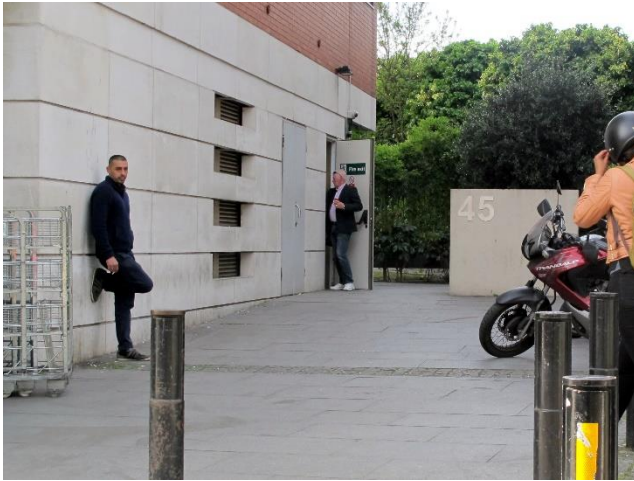
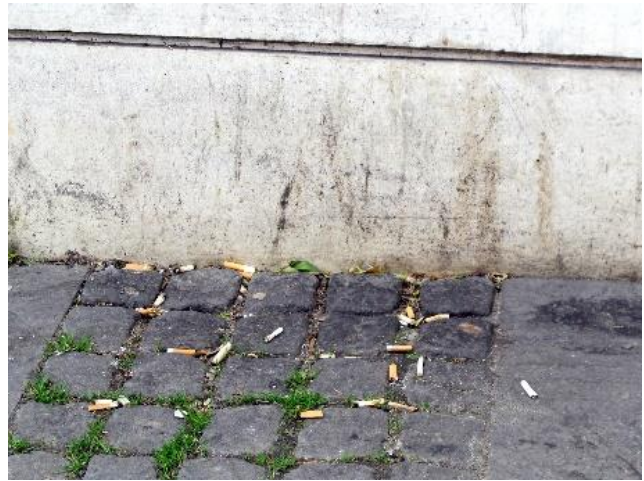
The whole area, both the part closest to the Pad and the area shared with the Magistrates Court and the Court Gardens entrance, is tatty and uncared for. Officially or not, it has become a parking place for motorcycles. It has also become a smoking and congregational area. Aspects of the design of the facade of the Pad may exacerbate this problem – the ventilation inlets are used as shelves for drinks and litter.

Tesco trolleys are stored and smokers congregate in the entrance area

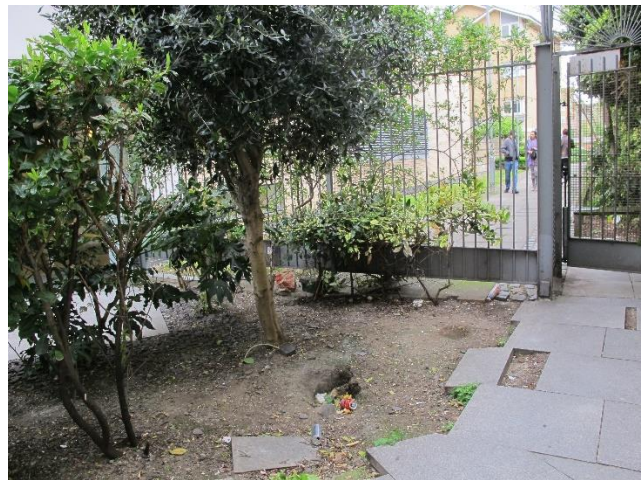
The paving is in places uneven and broken up.

Deep shelves of the façade directly to the ventilated inlets often become a littering spot, paving is broken up and uneven

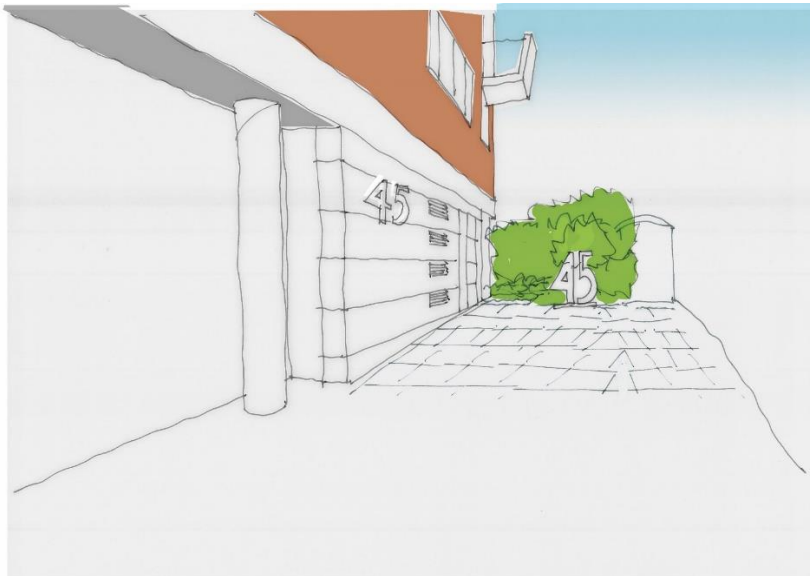
An indication of how signage might work with the plinth removed.

Removing the plinth entirely would immediately take away the focus for the problem. The garden area could then be tidied up and replanted (at the front, in place of the plinth, with dense, low-lying plants). Options of planting need to be considered with care; with the plinth removed, the trees currently behind it may become the next target for anti-social activity.

New signage could be added to the side of the building, either as a standalone post, fixed to the façade front on or to the side for easier identification from the main road. (See **addendum one** below for examples of building signage.)

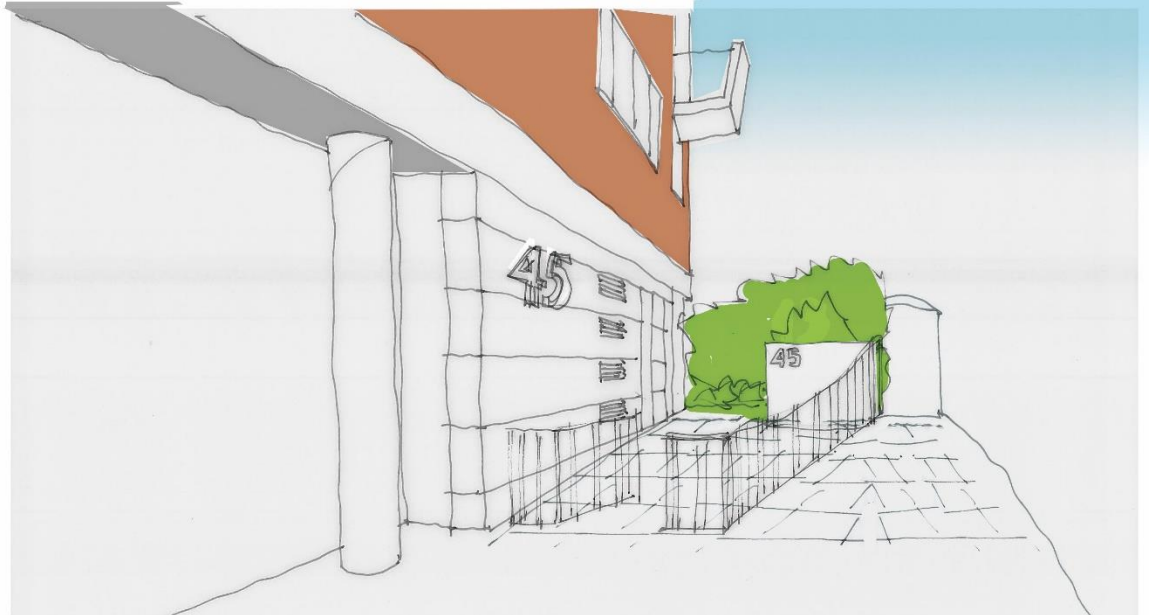
An indication of railings could be used to define an extended space and introduce a gate.

The picture below is indicative of a solution that attempts to go further and introduce new features to regenerate the entrance area. In the solution imagined below, railings extend to create a defined entrance area which could include a lockable entrance gate.

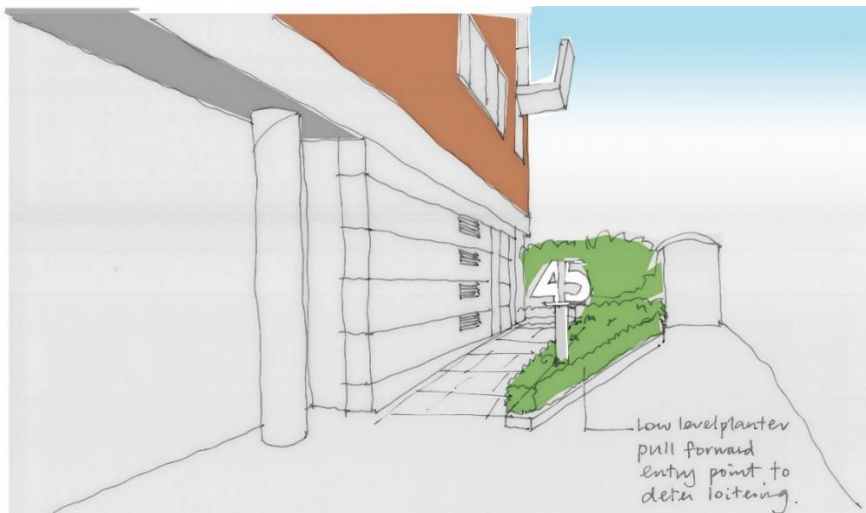
An indication of a simple planter design approach.

The raised bed could be a very simple structure or could be worked up into a more design-led feature. Below are some indications of what a solution along these lines could feel like. (See **addendum two** for examples of planters.)

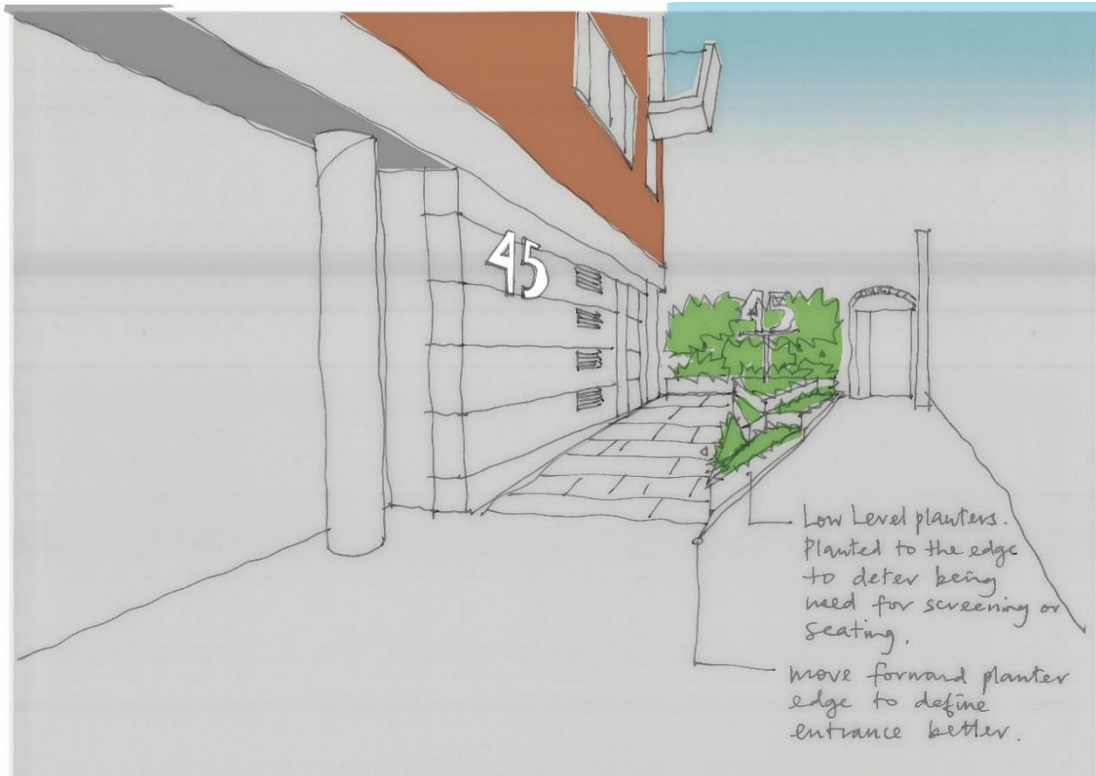
Low-level planter with more sculptural, stepped design

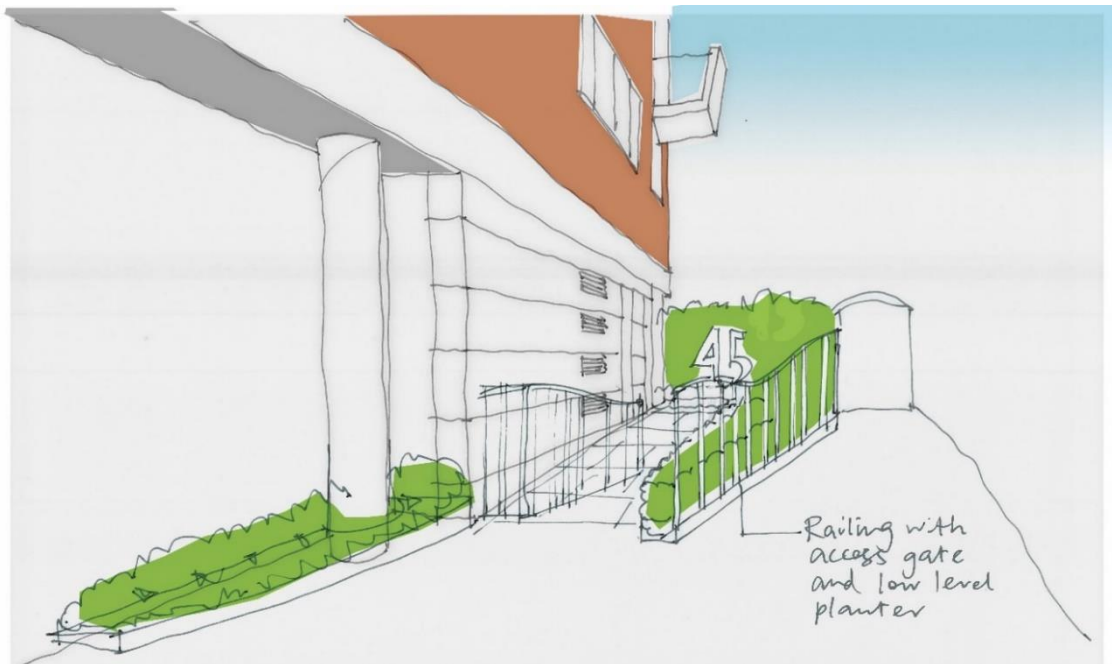
An approach incorporating the simple planting area with an additional planting, railings and gate

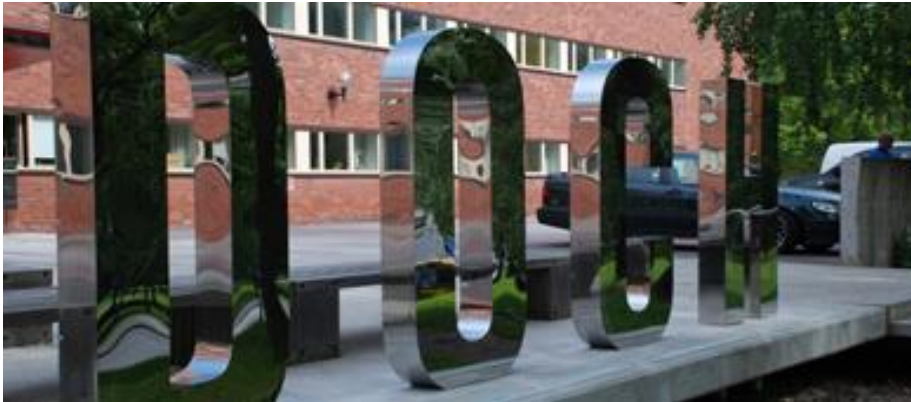
Type A - Large build up Metal signage

- Could replace plinth with large metal numbers and increase street level visibility
- Contemporary design, suitable for apartment block
- Could be costly
- Can consider smaller scale design to suit our block

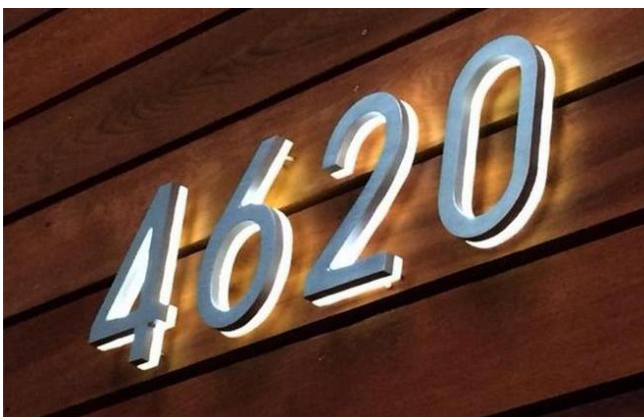
Type B – Metal signage, back lit

- Fixed to masonry façade
- Back lit for visibility
- Contemporary design
- May use in conjunction with Type A to increase visibility

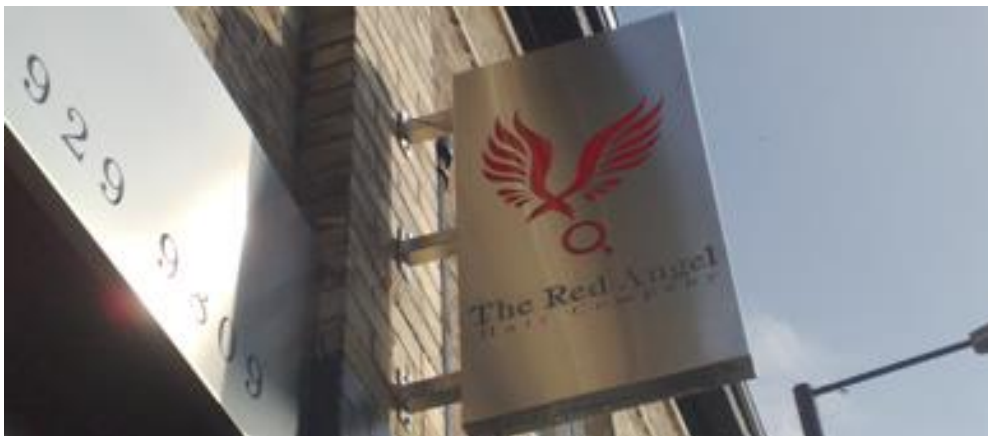
Type D – Fabricated signage hung from façade

- Fixed to masonry façade

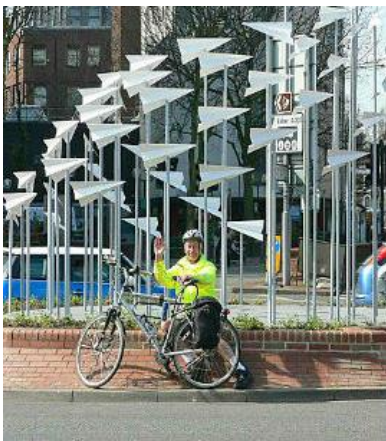
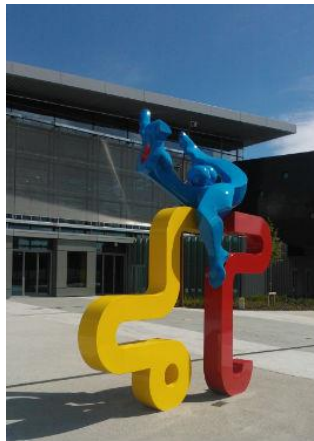
Sculptural elements to replace plinth and certain planting

- Visual openness
- Physical barrier
- Apartment block identity and signage incorporated

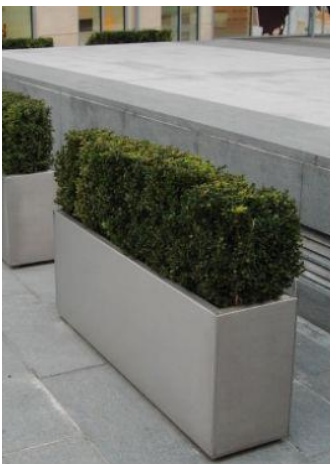
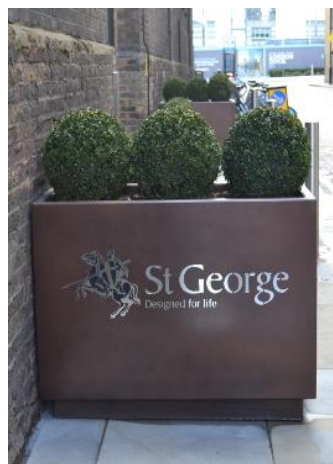
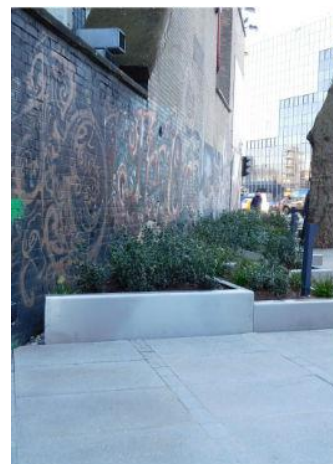
Low level planters

- Planters can create physical barrier with pleasant aesthetics
- Free standing, easy installation, well-built planters that resist vandalism
- Low level planting to remove screening and deter antisocial behaviour
- Fully planted and no edges for seating or littering.
